Oxford Street, Epping – Pavement rehabilitation using foamed bitumen stabilisation

By Alex Southey B.E. (Hons.)(Civil) MBA Business Development Engineer, Stabilised Pavements of Australia Pty Limited

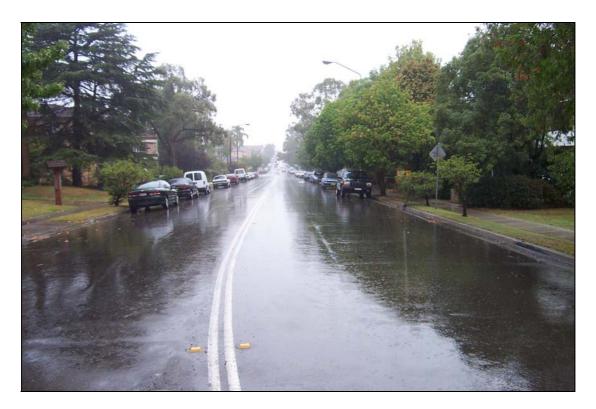
Figure 1 A view of Oxford Street after project has been completed.

The pavement appeared to be in good condition in March 2003 at the time of coring. The site was found to be in a similar condition when inspected again in early 2004, over five years after rehabilitation works were carried out.

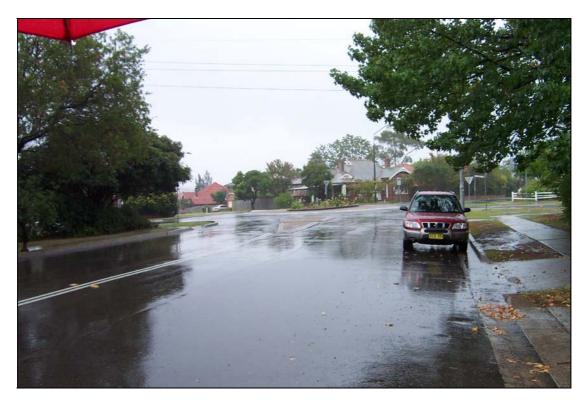
Figure 2 A view of Oxford Street near the roundabout.

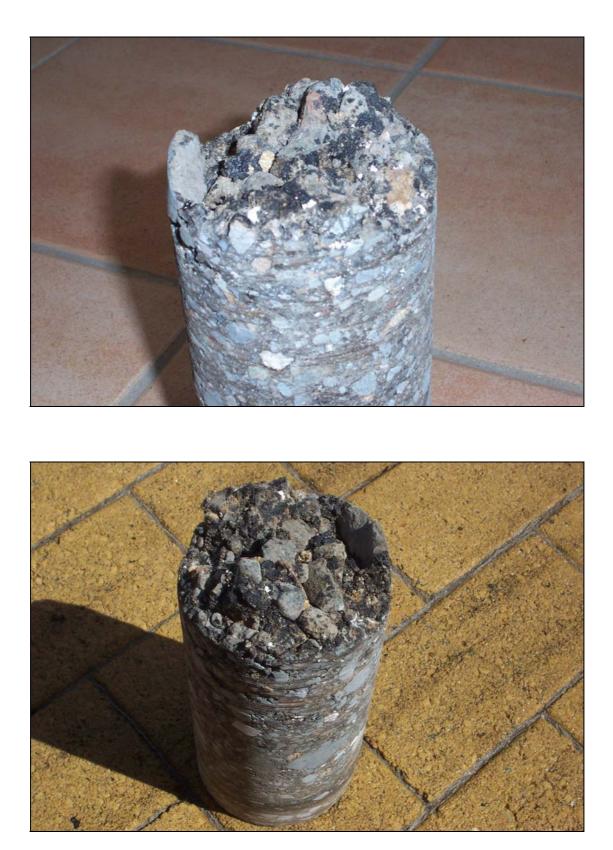
APPENDIX 2 – Core samples

When the samples were extracted, the bottoms of the cores were difficult to remove/obtain. Material at this depth showed a tendency to crumble and fall apart. This further indicates the lack of compaction achieved at the bottom of the stabilised pavement layer. The possible influence of the dry coring process, however, which created vibrations at the bottom of the core cannot be ruled out from influencing this.
