Great Ocean Road Pavement Rehabilitation

Thomas Gauci Downer EDI Works

2021 AustStab Awards of Excellence

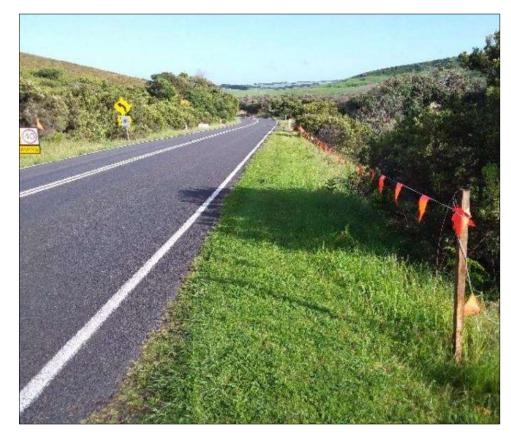
No Go Zone fencing installed

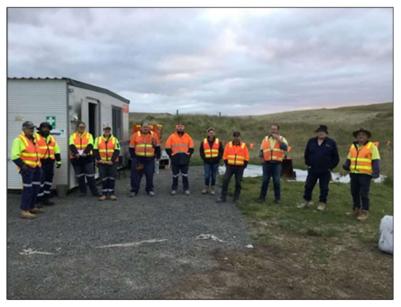
The Team delivering a quality result
