Healesville Kinglake Road Pavement Rehabilitation

Thomas Gauci, Project Engineer
Downer EDI Works

2022 AustStab Awards of Excellence

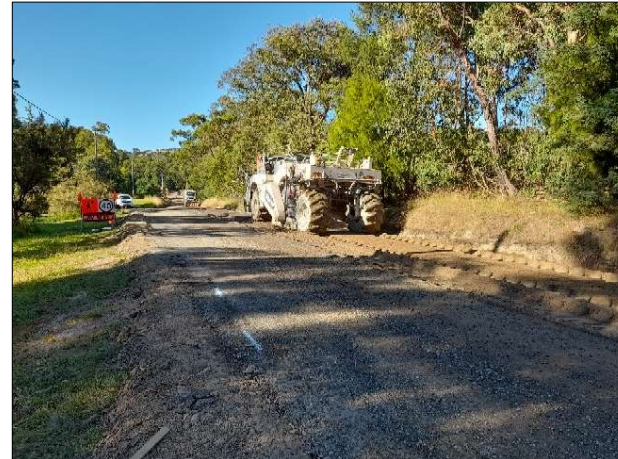
Figure 2: Working in Close Proximity to Native Vegetation

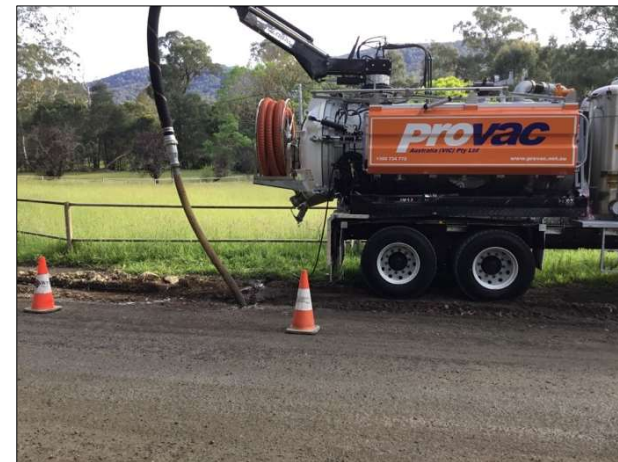
Figure 3: Locating Underground Services within pavement construction envelope

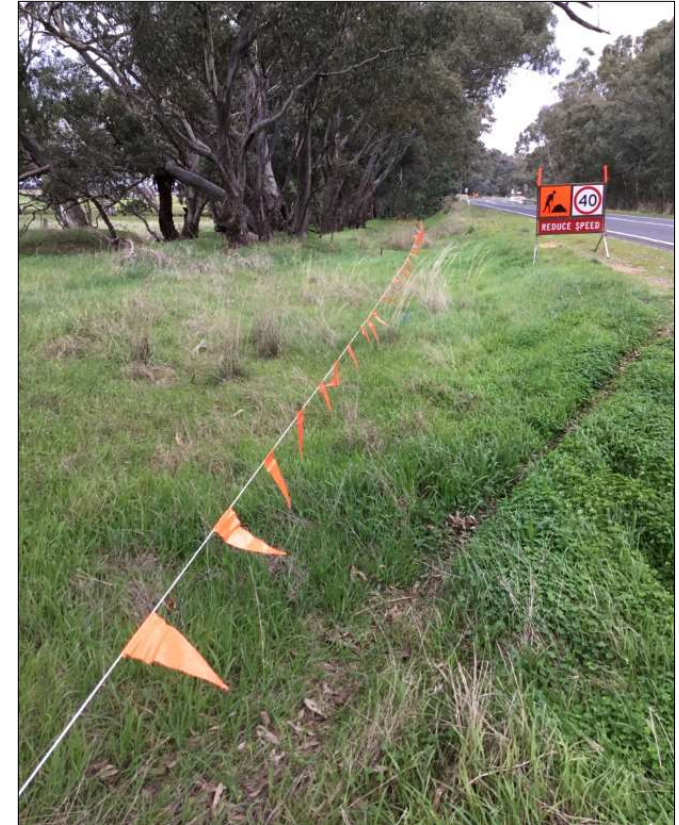
Figure 4: No Go Zone Fencing Installed

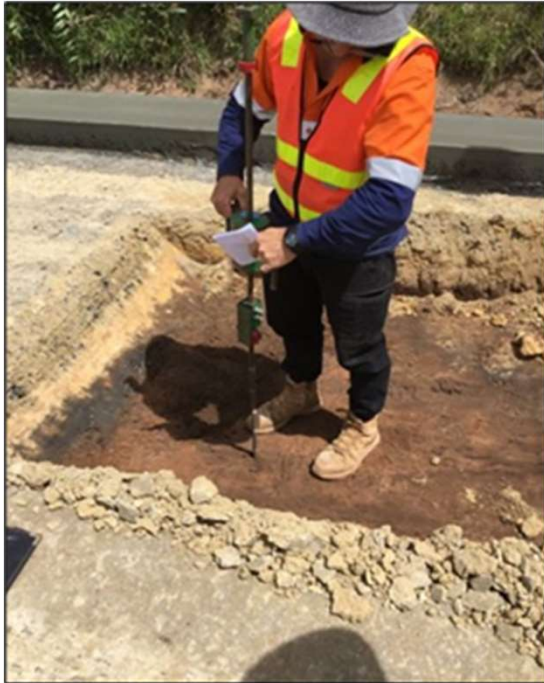
- Further investigation through the use of DCP testing revealed that the lower subgrade was of a very poor quality and did not possess the strength properties required for us to reach the required compaction.

Figure 5: DCP Testing
on Lower Subgrade
Layer

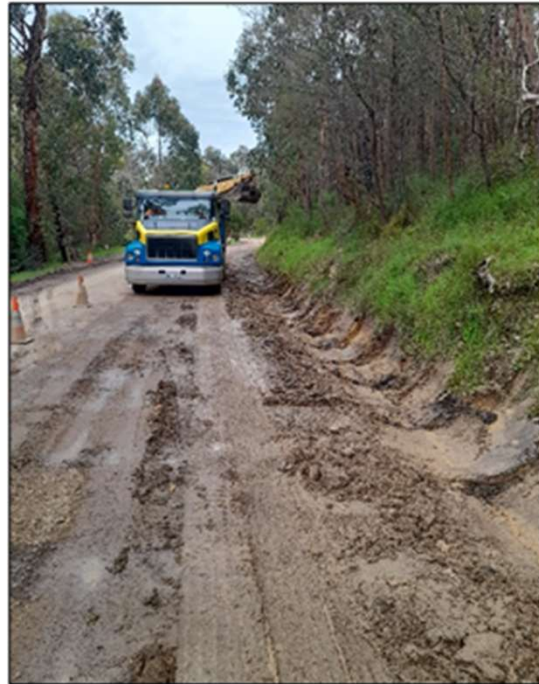
Figure 6: Struggling to
keep the Subgrade
Trafficable

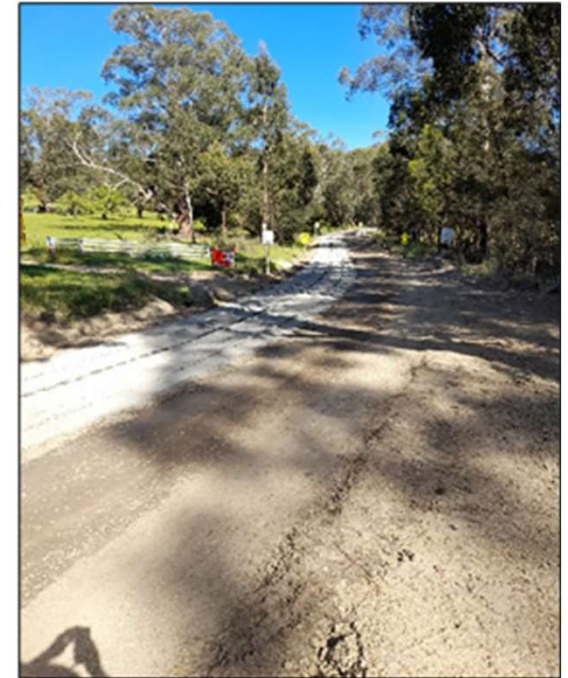
Figure 7: First run of
Cement Stabilising
Completed

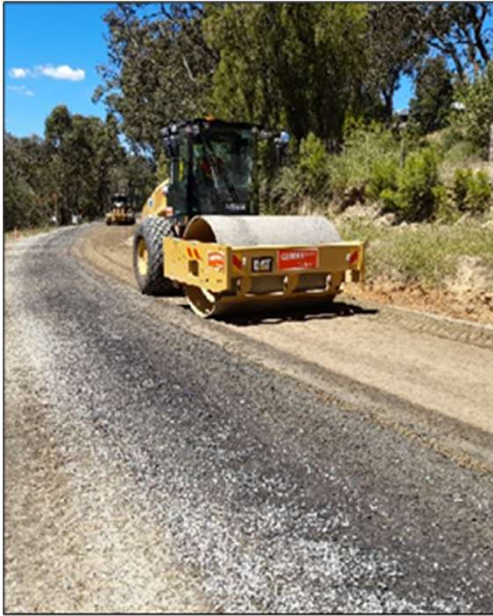
Figure 8: Compaction Effort on treated Subgrade Layer

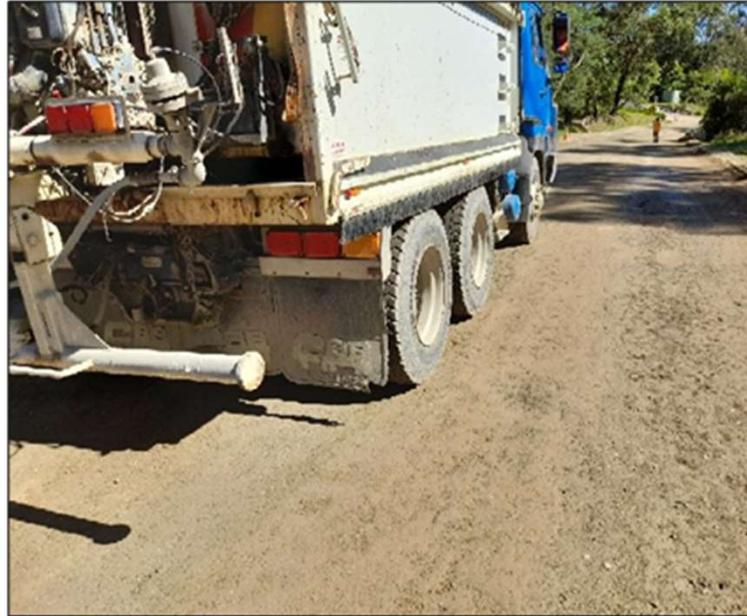
Figure 9: Proof Roll of Subgrade Layer & ITP Sign off with VicRoads
