# Improved Design & Construction Methodology for Urban Local Roads in Flood Prone Areas

Scott Young <sup>1</sup>, Zach Fryer <sup>2</sup>, Andrew Middleton <sup>3</sup>

## Abstract

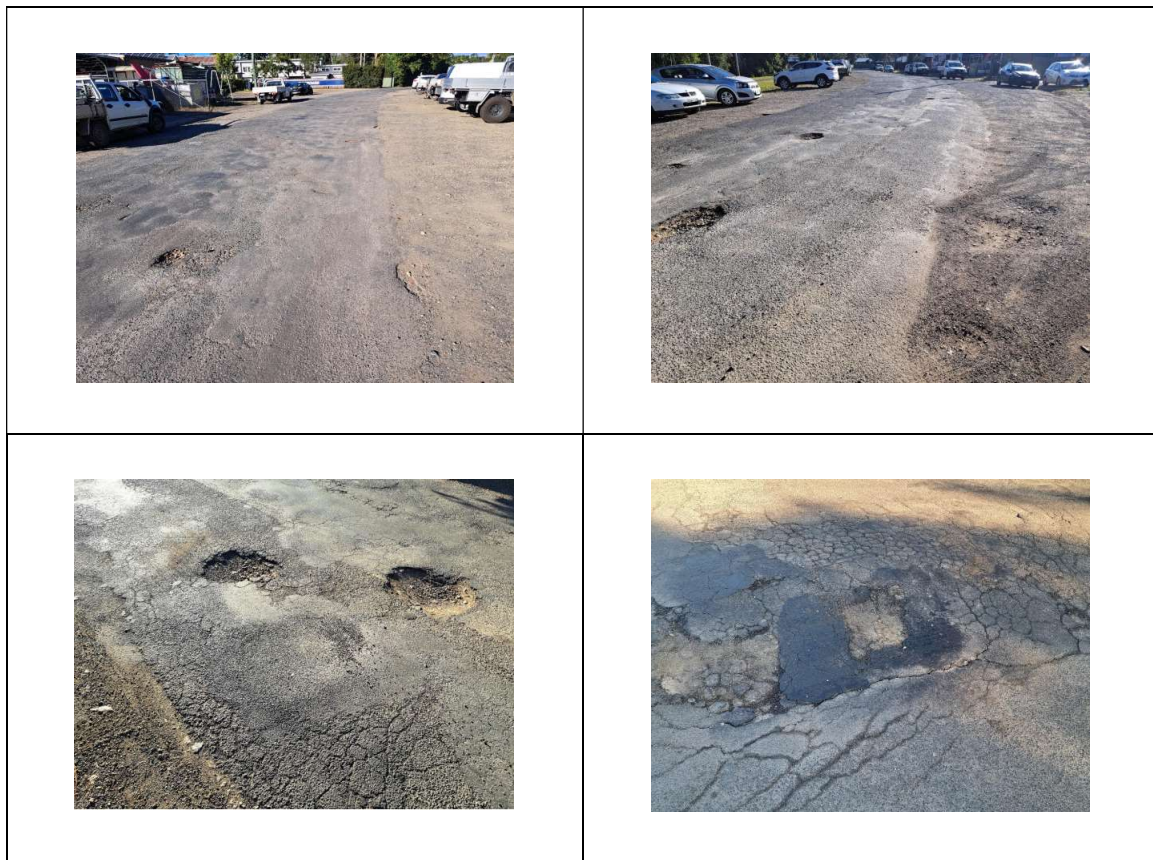
Figure 5: River Terrace Pavement Condition [2]

BSC identified that River Terrace was in need of repair due to the significant degradation observed in the wearing surface which showed signs of being caused by loss of integrity and structural capacity in the base course. BSC engaged an external consultant (Civil Consult) in the first half of 2023 to undertake a geotechnical investigation, supplemented by material sampling and laboratory testing. This work was to ultimately inform a series of pavement design options in a pavement rehabilitation report for BSC to consider. Their intent was to implement the rehabilitation works in the 2024 financial year. After BSC reviewed the report, they concluded that their budgeted funds for the project were unable to support any of the pavement rehabilitation design options.

The images below have been reproduced from the Civil Consult report, indicating the condition of the pavement in mid-2023.

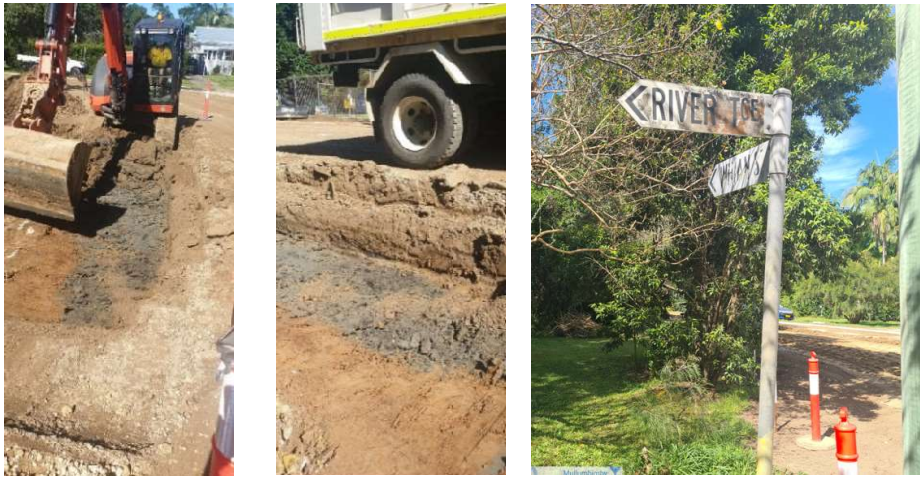
Figure 16: Soft Subgrade Repair

Although the total project time was 21 days, only 6 days were required where construction activities took place. After the initial lime stabilisation treatment was completed, there were two areas that exhibited deformation. The first was at the corner of River Terrace and Whian St. This was the lowest point of the site and Council noted this location had previously been subjected to numerous repairs. A soft subgrade replacement was undertaken by BSC which constituted less than 20m<sup>2</sup>. The second area was slightly east of the previous noted location, in Whian St where a shallow domestic water service that traversed across the road was damaged during the recycling process. This caused an increase in moisture filtering into the subgrade in the immediate area. The SAMI seal was also delayed due to wet weather conditions.

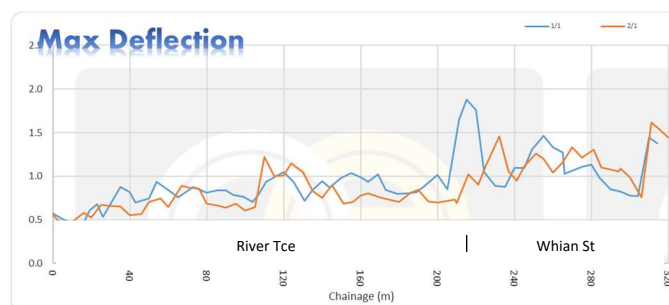
Figure 26: Maximum Deflection [3]

The high deflection between CH200 and CH240 was caused by the soft subgrade that was repaired at the corner of River Terrace and Whian St. The deflections in Whian St are generally higher than those in River Terrace, likely to have resulted from the slower dry back period after the rain event that occurred prior

to the pavement being sealed. This was because Whian St has significantly more shady conditions compared to River Terrace. Further deflection tests in the future will likely produce more realistic indications of the pavement stiffness.
