Improved Design & Construction Methodology  
for Urban Local Roads in Flood Prone Areas

Scott Young, Zach Fryer, Andrew Middleton  
Byron Shire Council / Stabilised Pavements of Australia

## *2024 AustStab Awards of Excellence*

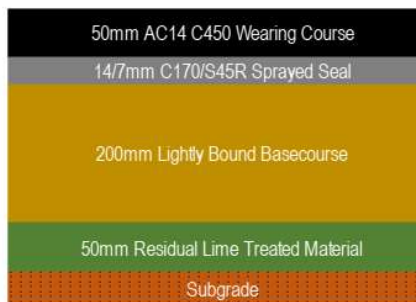
Figure 10: Pavement Design Cross Section

- The design solution presented to BSC was a process involving a double stabilisation treatment as follows:-
  1. Mix lime into the existing pavement and subgrade (ie. Basegrade stabilisation), the intent of this process being to lower the position of top of subgrade to 300mm below the existing surface level without any excavation, all of the existing wearing course to be incorporated into the mix

2. A curing period of 3 days minimum was nominated to allow the lime treated materials to ameliorate then the top 50mm of the treated material was to be removed to accommodate placement of the final wearing surface

3. Strengthening process would then take place to using a second stabilisation treatment to the design thickness of 200mm to generate a lightly bound base course layer defined as having a UCS in the 1-2mpa range

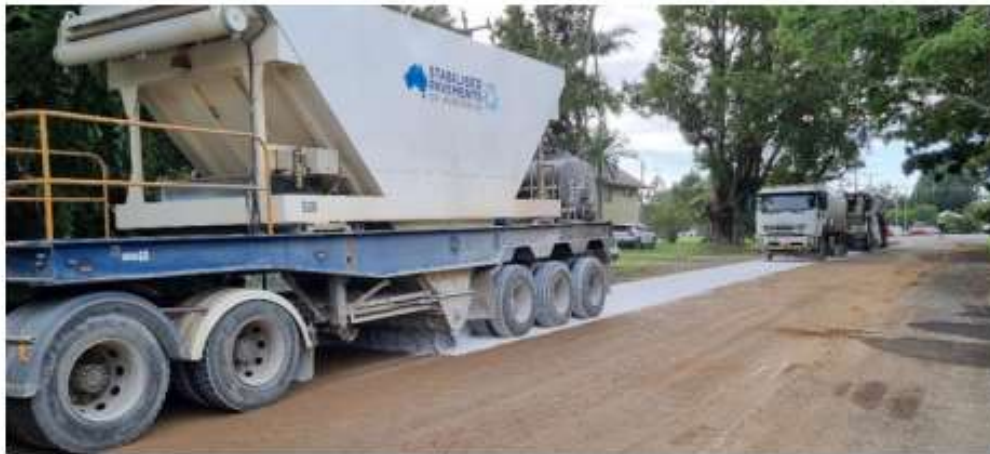
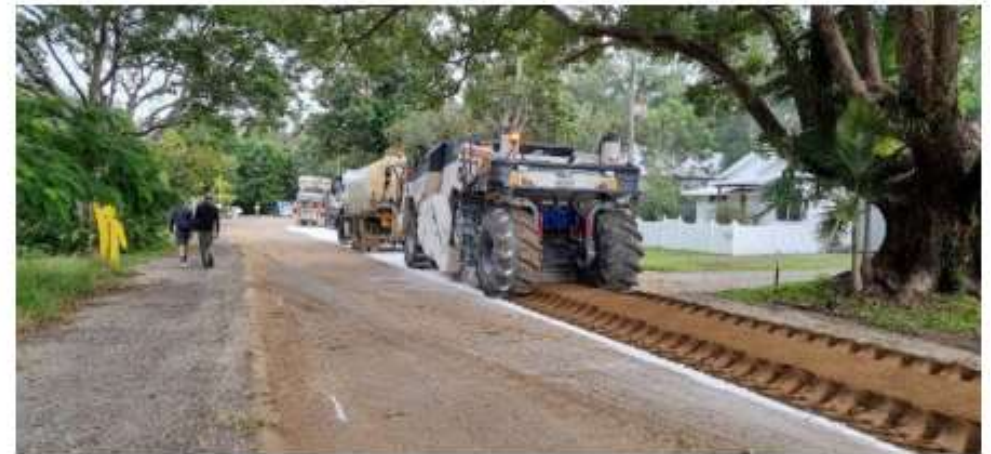
Figure 14: Spreading and Mixing Lime

- Although the total project time was 21 days only 6 days were required where construction activities took place, 2 isolated small areas of subgrade were also replaced by BSC, one of those resulting from a water damaged service during the recycling process.
- “Low Dust Emission” spreading & mixing techniques were utilised throughout the stabilisation stages of the construction process, this involved placing the stabilisation additive powder on the surface for short controlled distances only in front of the stabilising mixer/recycling machine and having a watercart coupled to the mixer at all times to allow moisture to be added for compaction and for dust control.

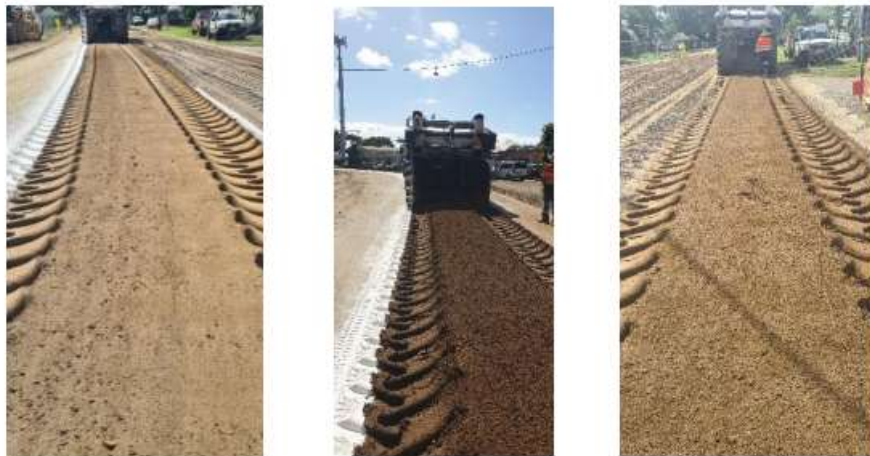
Figure 24: Material Uniformity

The Coefficient variation of the two sets of results from the 17th and 26th was 12% and 10% respectively, the image below (figure24) illustrates how uniform the material appeared from a visual perspective after the slag / lime phase. This was attributed to the initial pre pulverisation phase which considerably improved the uniformity of insitu materials.
