Category 3: Excellence in Sustainability and Innovation

WA Pacific Freight Terminal, Roadway F, Foamed
Bitumen Stabilised Intermediate Course

2024 AustStab Awards of Excellence

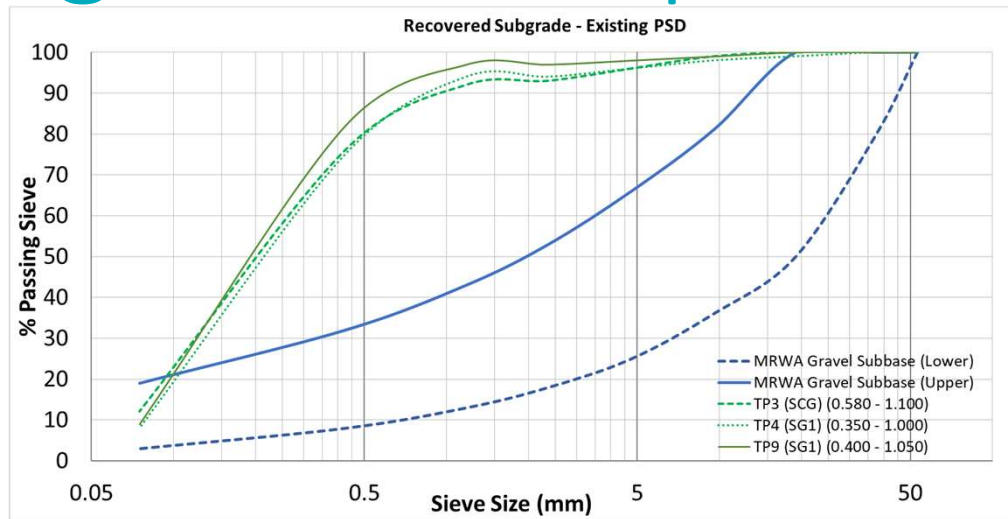
- Subgrade material had fine grading and being a clean sand was considered for inclusion in the FBR layer.
- This would be confirmed during the mix design process.

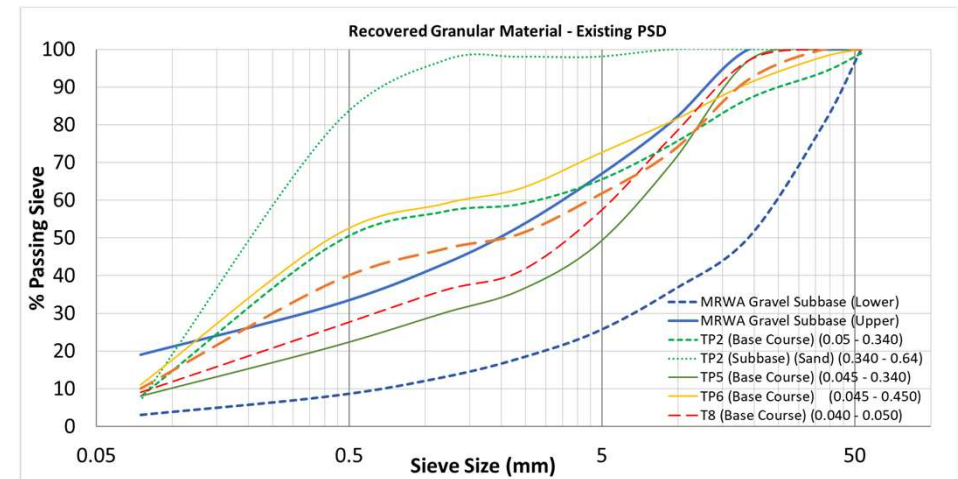
- Recovered granular material graph on the right reports the gradings of the tested material.
- TP2 included a subbase with a very fine grading, similar to the subgrade material, hence it was considered to be a subgrade material.
- The conclusion was that additional imported granular material would be required to improve the grading curve to fit within the grading limits. This equated to be 20% and 25% for Section 1 and 2 respectively.
- The incorporation of the imported quarried granular was deemed necessary to ensure the minimum 7 day cured modulus of 2000MPa would be achieved.

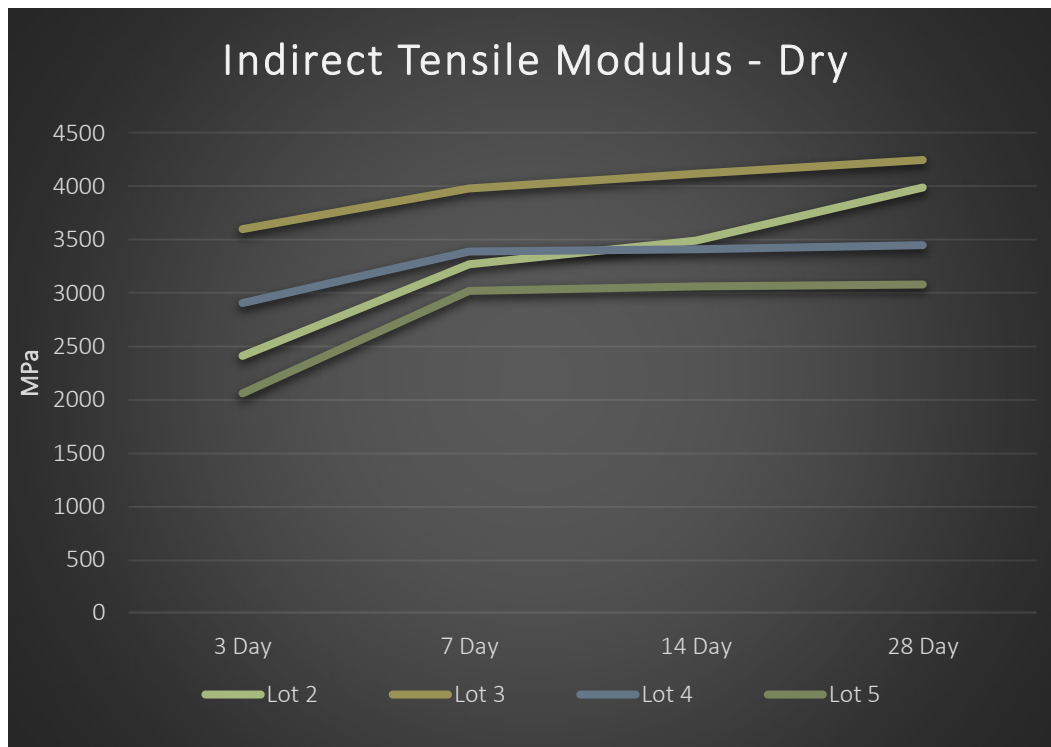
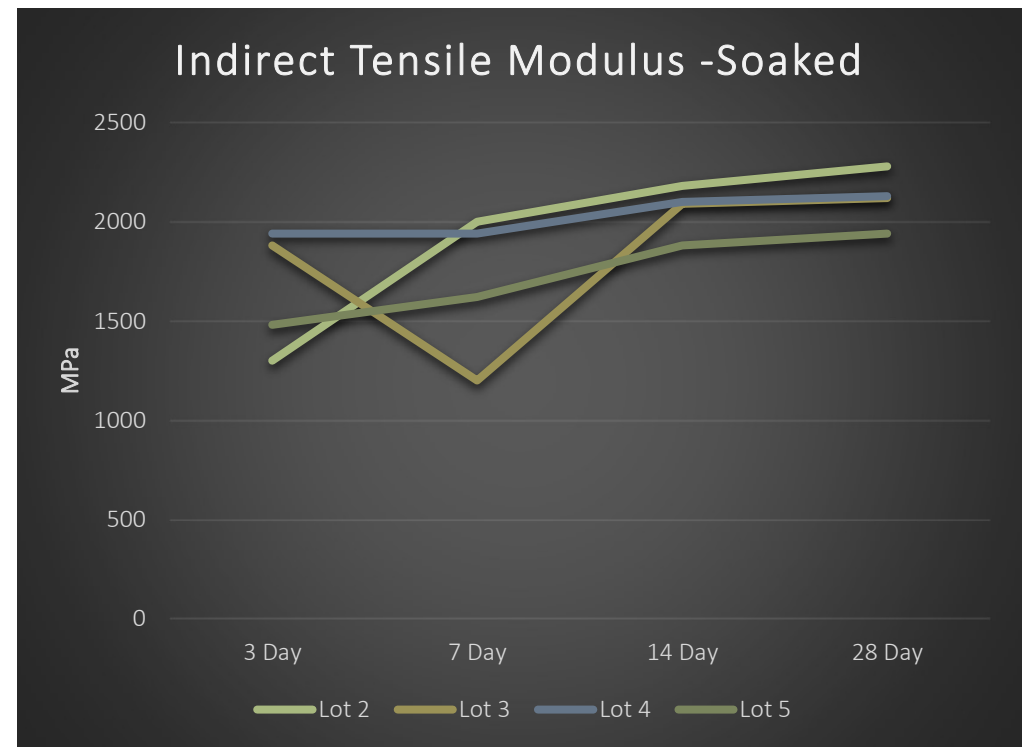
Construction Modulus Results

- During the design phase it was agreed that 3, 7, 14 and 28 day modulus testing would be undertaken on the constructed FBS material. This was agreed as the pavement would be delayed in trafficking and allowed the FBs layer to gain strength, this was identified early in the design phase.
