# Improved Design & Construction Methodology for Urban Local Roads in Flood Prone Areas

Scott Young <sup>1</sup>, Zach Fryer <sup>2</sup>, Andrew Middleton <sup>3</sup>

## Abstract

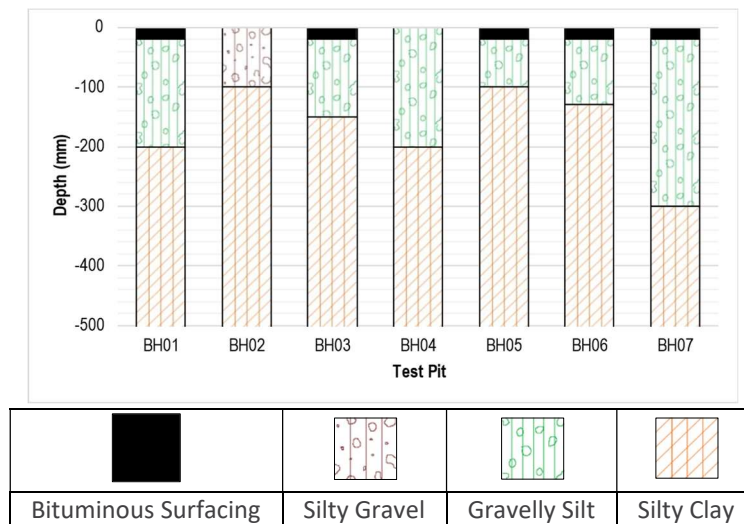
Figure 8: Existing Pavement Profile [4]

Excluding BH02 and BH04 (shoulder profiles), there was barely 200mm of material above the silty clay subgrade. This was validated when SP Design undertook an independent material sampling exercise in December 2023.

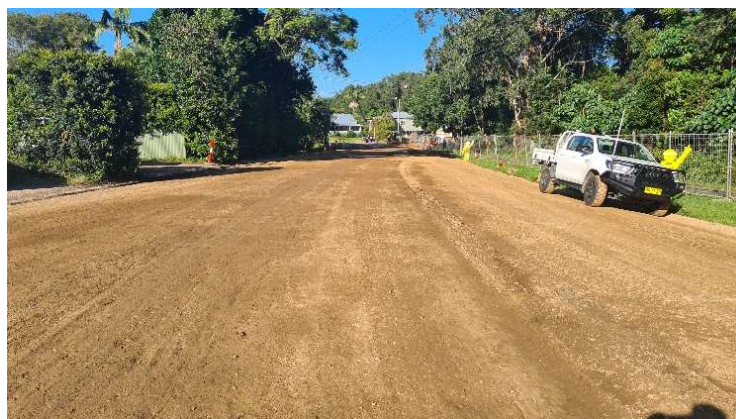
Figure 15: Lime Treated Pavement during Amelioration Period

Although the total project time was 21 days, only 6 days were required where construction activities took place. After the initial lime stabilisation treatment was completed, there were two areas that exhibited deformation. The first was at the corner of River Terrace and Whian St. This was the lowest point of the site and Council noted this location had previously been subjected to numerous repairs. A soft subgrade replacement was undertaken by BSC which constituted less than 20m<sup>2</sup>. The second area was slightly east of the previous noted location, in Whian St where a shallow domestic water service that traversed across the road was damaged during the recycling process. This caused an increase in moisture filtering into the subgrade in the immediate area. The SAMI seal was also delayed due to wet weather conditions.

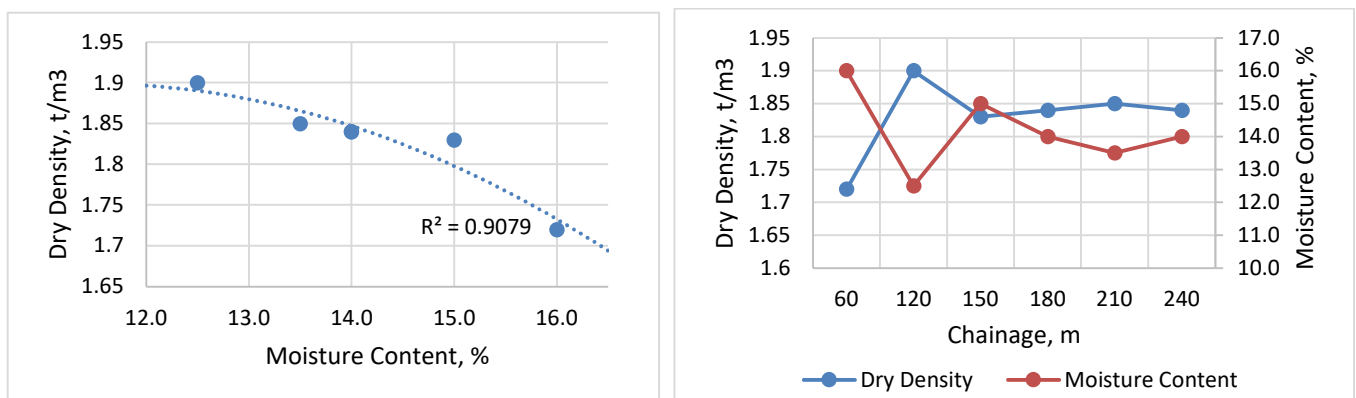
Figure 21: Dry Density v Moisture Content Post Lime Stabilisation

The density testing was performed on samples retrieved from 6 locations along the length of the site. Although the density ratios were observed to be favourable, the key indicator of success was the low coefficient of variation of the maximum dry density (MDD) and the optimum moisture content (OMC) determined from each sample extracted from behind the stabiliser that had mixed in the 60/40 slag/lime. This is illustrated below (chainage zero was at the southern end of the site).

The average Dry Density and Moisture Content was 1.83t/m<sup>3</sup> and 14.2% respectively. Both sets of data had a coefficient of variation less than 9%, indicating material uniformity.

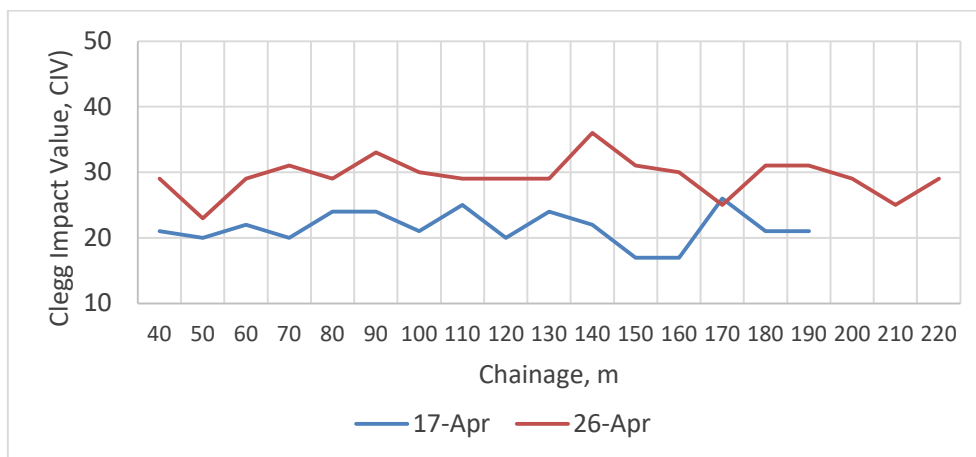
Figure 23: Clegg Impact Value

The results of the Clegg Hammer testing below (chainage zero was at the northern end of the site) further demonstrates the material uniformity that was created.

The coefficient of variation of the two sets of results from the 17<sup>th</sup> and 26<sup>th</sup> April was 12% and 10% respectively. The image below illustrates how uniform the material appeared from a visual perspective after the slag/lime stabilisation phase. This was attributable to the initial prepulverisation and crossblending phase, which considerably improved the uniformity of insitu materials.

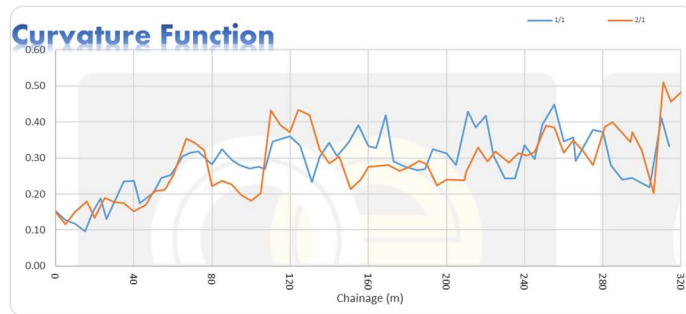
Figure 27: Curvature [3]

The high deflection between CH200 and CH240 was caused by the soft subgrade that was repaired at the corner of River Terrace and Whian St. The deflections in Whian St are generally higher than those in River Terrace, likely to have resulted from the slower dry back period after the rain event that occurred prior

to the pavement being sealed. This was because Whian St has significantly more shady conditions compared to River Terrace. Further deflection tests in the future will likely produce more realistic indications of the pavement stiffness.

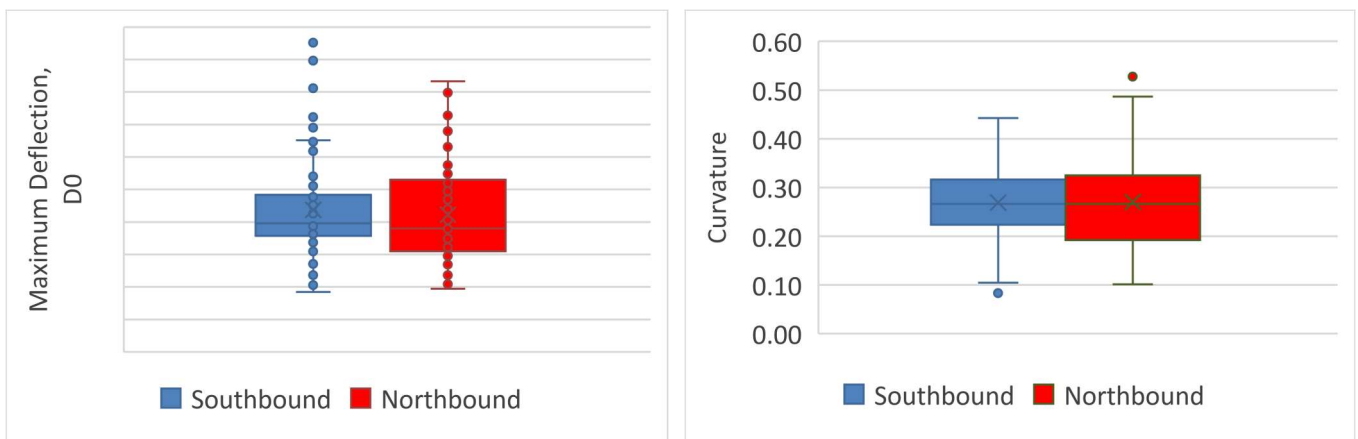
Figure 28: Max. Deflection (L) and Curvature (R)

The consistency in deflection and curvature of the pavement, particularly between the southbound and northbound lanes is illustrated in the plots below. Both sets of plots indicate reasonably consistent material stiffness onsite, based on the similar medians and small size of quartile ranges in the ox and whisker plots, as well as the very good correlation between the deflection and curvature values.
