Category 4: Excellence in Pavement Recycling and Stabilisation in Local Government

#### Foamed Asphalt in Palm Beach: A Queensland First

Darrin McNeilage, City of Gold Coast and Scott Young, Stabilised Pavements of Australia

#### 2021 AustStab Awards of Excellence

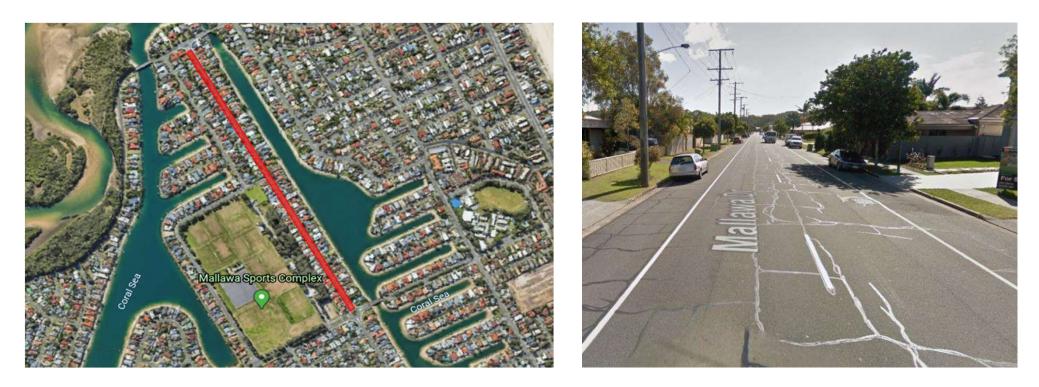
The section in red is a 1km length of Mallawa Drive in Palm Beach that was subjected to additional post-construction testing to verify uniformity of mixing in the horizontal and vertical directions. The image on the right shows the same section of Mallawa Drive prior to construction. It was a previously cement stabilised pavement that was last treated in the 1990s

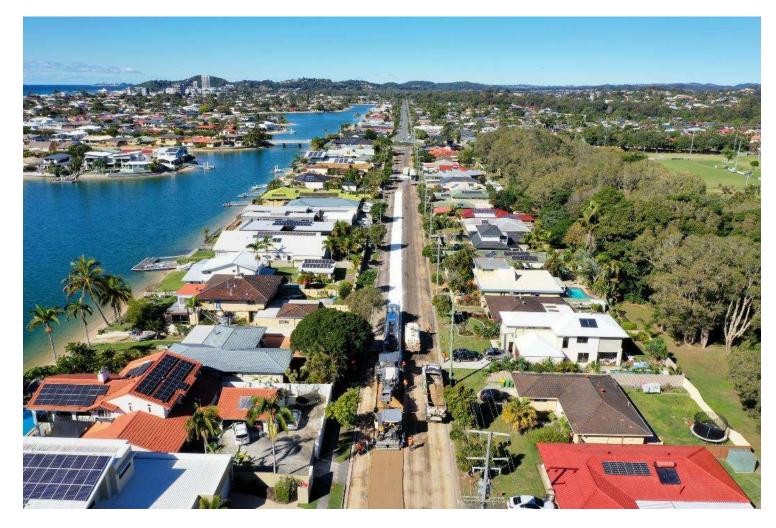
Aerial shot of the foamed asphalt process underway at Palm Beach on Mallawa Drive. Evidence of the highly populated and environmentally sensitive location along the canals on the eastern side of the road and bushland on the western side of the road.

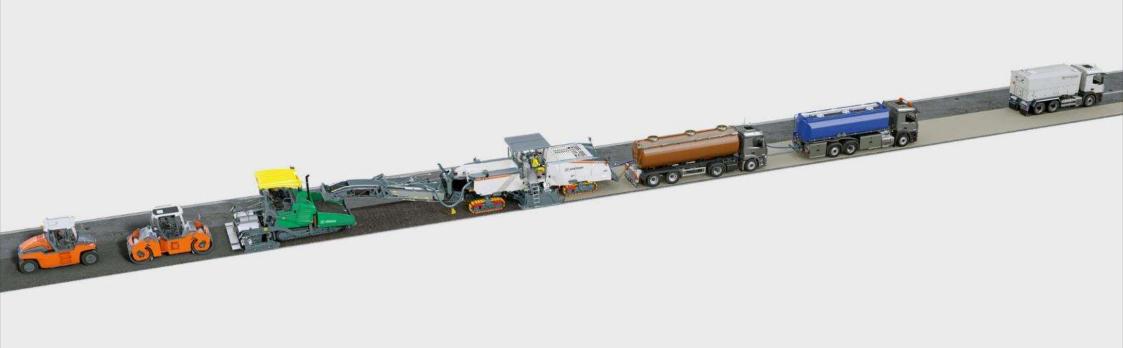
## The Construction Train

The entire construction train moves only in a forward facing direction. This provides increased safety benefits over other processes.

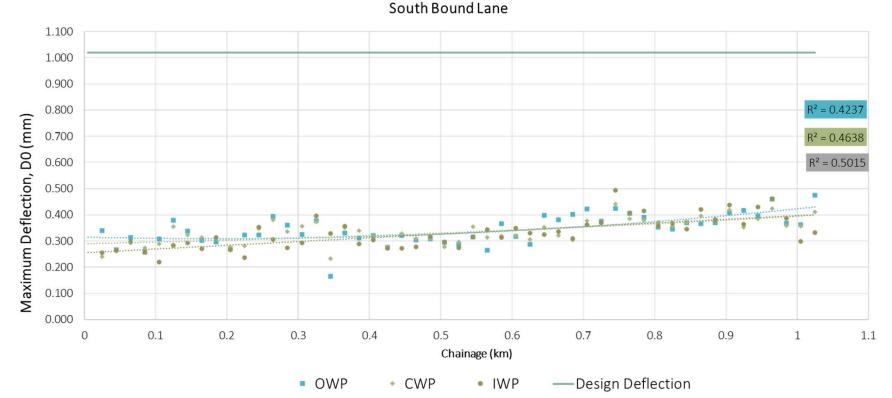
This plot shows an example of the deflections measured approximately 3months post rehabilitation in the southbound lane. The aim was to observe the variation (or lack thereof) in deflection across the width of the lane from 3 FWD drops across the lane – being outer wheel path (OWP), centre wheel path (CWP) and inner wheel path (IWP).

The results are not only significantly under the design deflection of 1.04mm, but are very consistent across the 3 lane locations. This supports the uniformity of mixing produced by the single pass down cutting process.

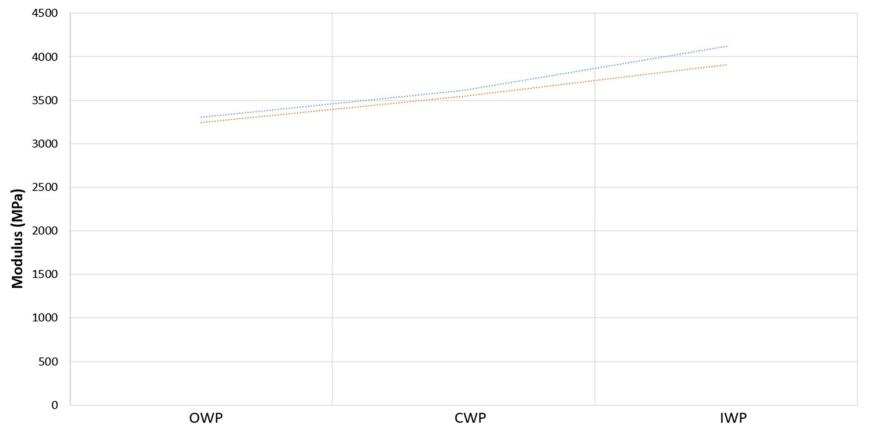
This plot illustrates the low variation in back calculated cured modulus from the FWD testing between the 3 transverse lane locations along the length of the test site, which was 1km. Results are displayed in average values.

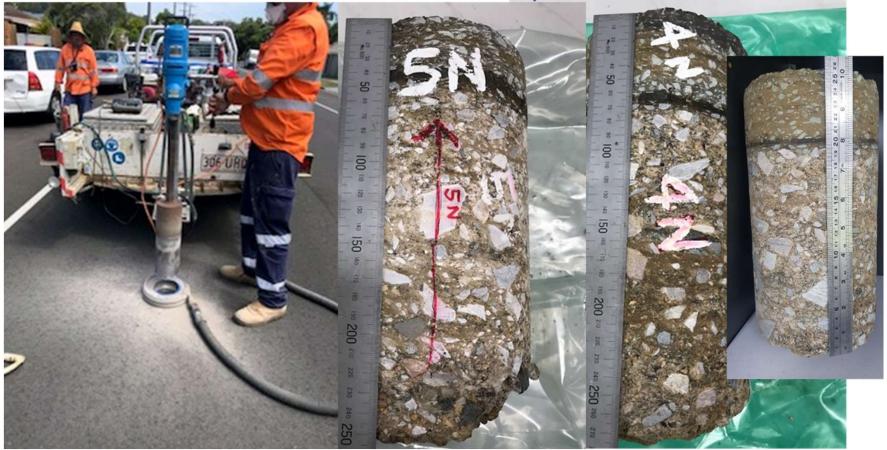
18 cores were extracted from the 1km length, 9 from each direction. Modulus testing was undertaken on the top and bottom of each core. Cores were approximately 4 months old.

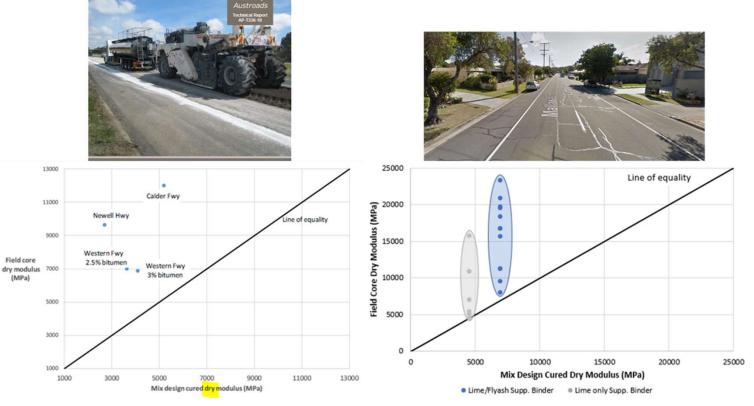
This is a direct comparison of the dry moduli obtained from the extracted cores after 4 months of field curing versus the same evaluation performed by Austroads in their Foamed Bitumen performance project which showed the increase in field core modulus was approximately 2.5-3.0 times the mix design modulus. The effects of the fly ash as a filler to correct the deficiency in fines was clearly evident in higher strengths on Mallawa Drive, however the same 2 5-3 0 ratio was observed
